## ERRATA LIST

### **Apollo3 Blue Plus SoC**

Doc. ID: SE-A3P-7p0

Doc. Revision: 7.0, August 2026

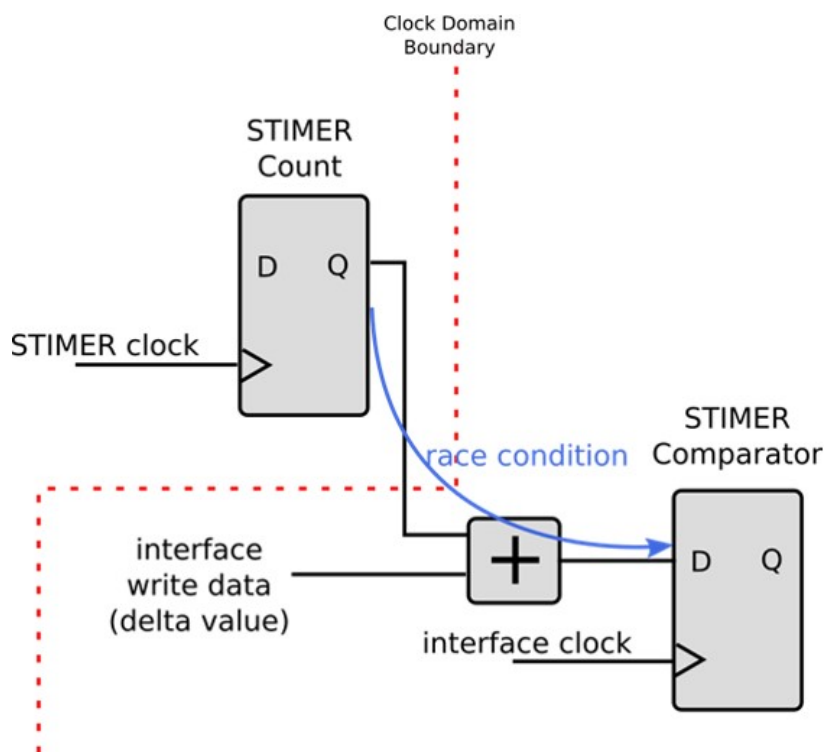
Figure 1. STIMER Compare Register Update Race Condition

The STIMER compare register may capture invalid data as the add operation is in the process of computing the new value. Thus there is a race condition between the STIMER clock and the interface clock.
