## ERRATA LIST

### **Apollo3 Blue Plus SoC**

Doc. ID: SE-A3P-6p0

Doc. Revision: 6.0, December 2024

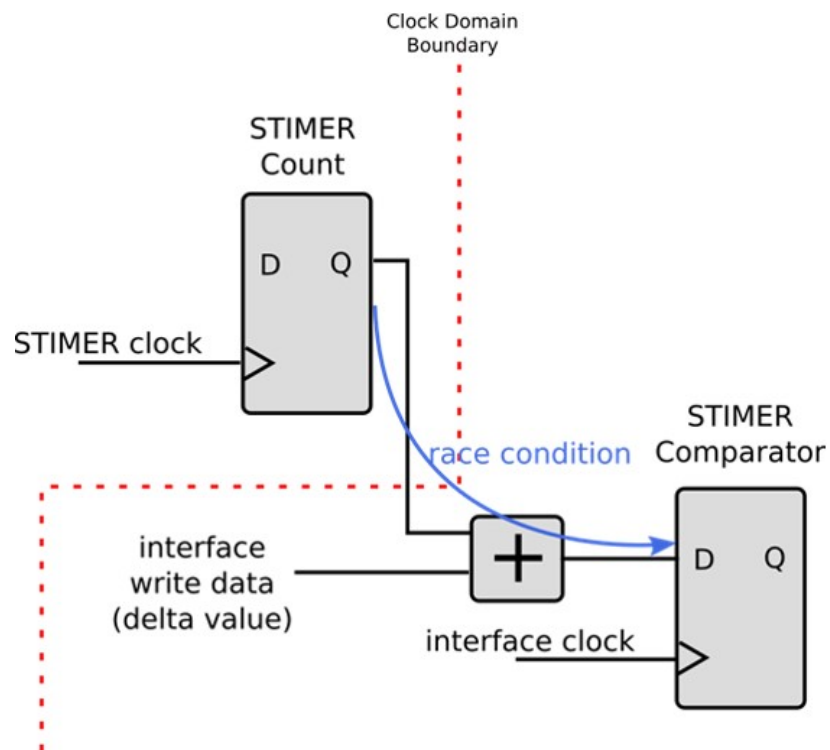
Figure 1. STIMER Compare Register Update Race Condition

The STIMER compare register may capture invalid data as the add operation is in the process of computing the new value. Thus there is a race condition between the STIMER clock and the interface clock.
